**THE IMPACT OF TRENCHING ON
URBAN ROAD OPERATION AND
MAINTENANCE**

The Impact of Trenching on Urban Road Operation and Maintenance

Bachelor of Engineering (Civil)

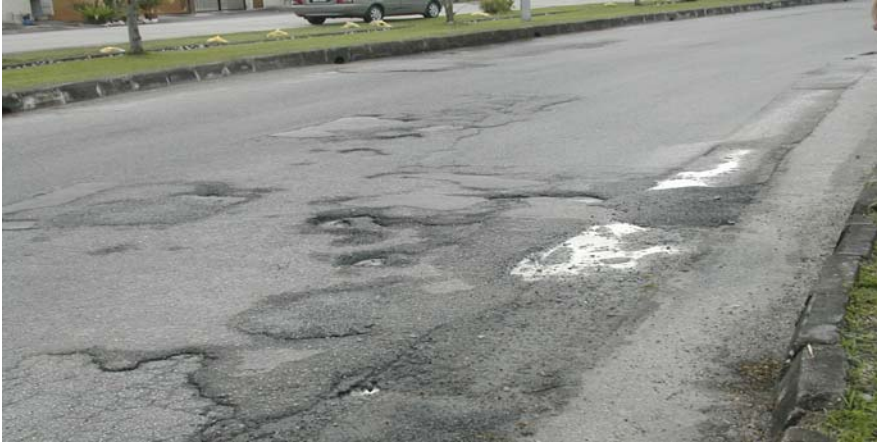
Figure 2.1: Pavement Deterioration from Trenching Work

Of the 10 causes of pavement deterioration, traffic loading and potholes are the two main causes of pavement deterioration in trenching works. When a particular road has been patched up after trenching work has been done, it is expected to settle within 6 months. During that time, due to constant traffic loading, the roads which had been patched up are usually settled to a level below the existing road level. Due to rain collecting inside the hole, stripping occurs and further deteriorates the road

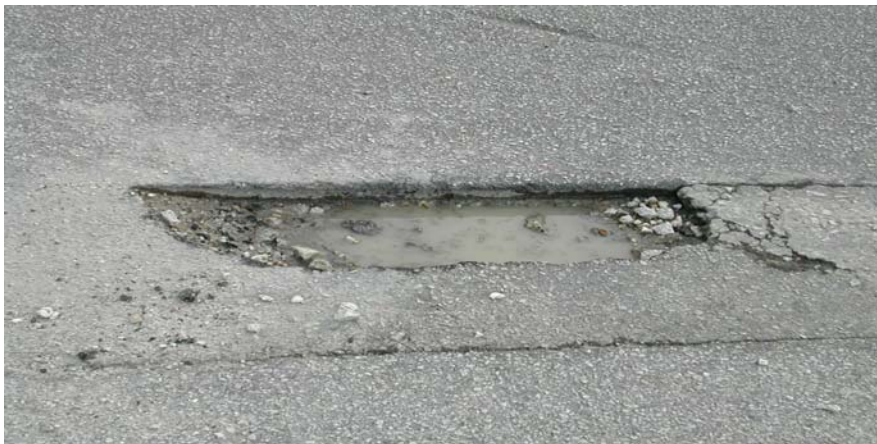
These are small bowl shaped depressions, usually less than 0.9 meters in diameter, having sharp edges and vertical sides near the rim. Water collecting inside the hole causes further deterioration. Potholes usually occur as a result of traffic dislodging small pieces of surfacing in areas where the binder has become embrittled or subjected to stripping in the constant presence of water. If not combated effectively early on, the hole may expand to affect the foundations.

Figure 2.2 : Pothole

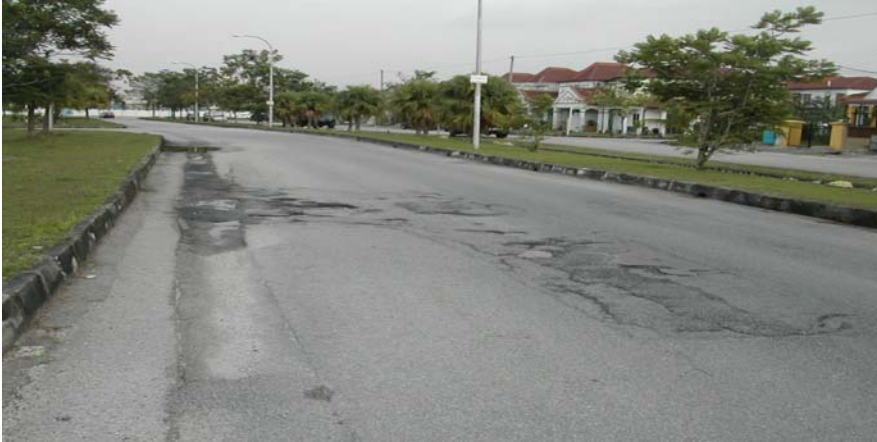
Carriageway markings that have been worn away by traffic must be reinstated for the safety of road users. This activity may be included as part of a Cyclic maintenance regime.

Figure 2.3: Reinstated Pavement without Road Marking

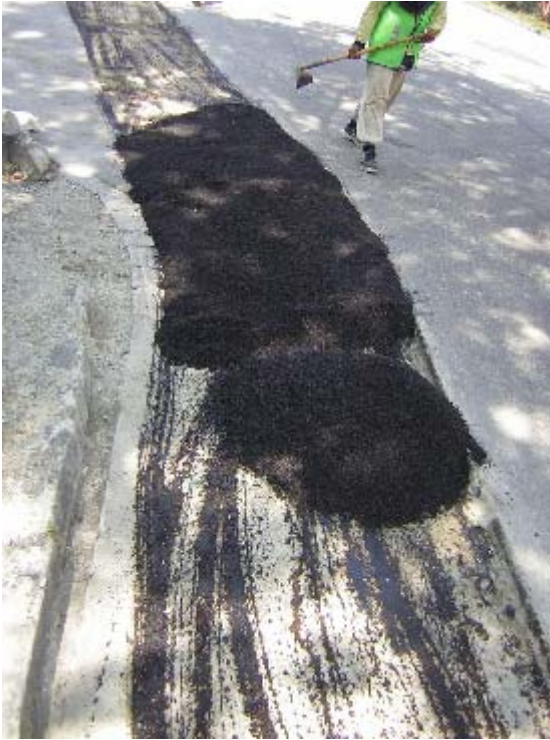
Prior to the application of tack coat, the existing surface needs to be cleaned. This would mean a smooth even surface. Tack coat is then applied evenly to the surface. The laying and rolling of asphalt should be of appropriate temperature. Asphalt is then compacted to ensure that they are settled and smoothly connected to other roads.

Figure 2.4: Laying of Asphalt After Tack Coat is Applied

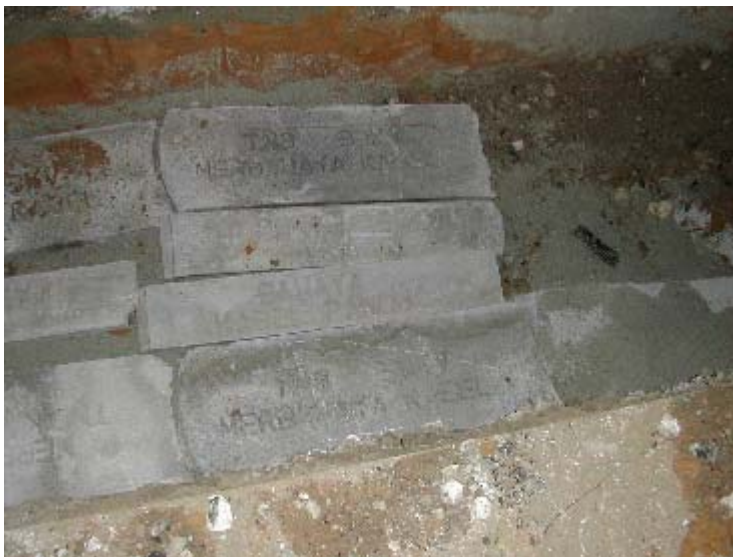
Trenches were kept as straight as possible and the bottom of the trenches were level and smooth without stones or hard lumps. According to the drawings submitted by Pembinaan Tajri Pte. Ltd. for approval, the bottom of the trench should be filled with sand to a thickness of 100 mm to form a bed before cables are laid. However, cables were actually laid on the bottom of the trench without a layer of sand. After the pipes were laid, fine sand of approximately 300 mm depth, measured from the top of the corrugated pipe, were filled into the trench. A protective cover made out of reinforced concrete was placed atop of the sand. The protective cover functioned as a precaution as well as a notice indicating an electric cable located 300 mm beneath the cover.

Figure 5.1: Protective cover

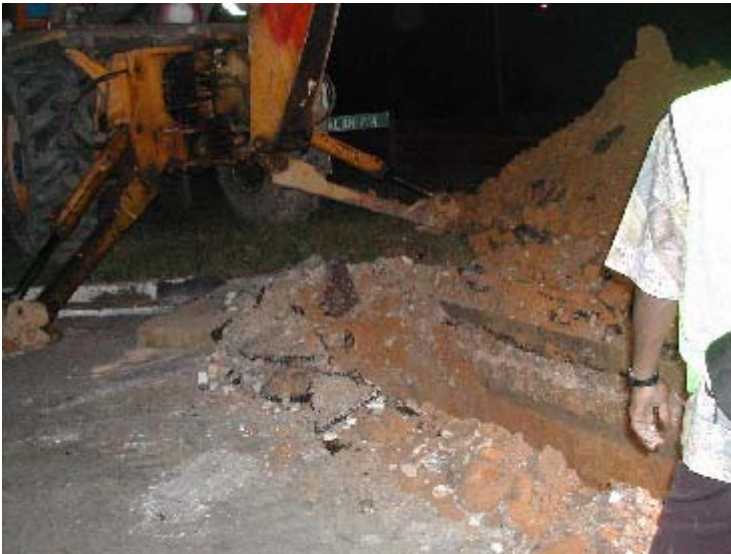
Excavated material was deposited neatly beside the open trench. It was placed neatly so that it caused minimum disturbance to traffic and accessibility to the property. After backfilling of trench, the surplus material was removed by using a loader with backhoe attachment to haul the material onto highway trucks. The trucks then off loaded the surplus material at a suitable place.

Figure 5.2: Excavated Material Deposited Beside Open Trench

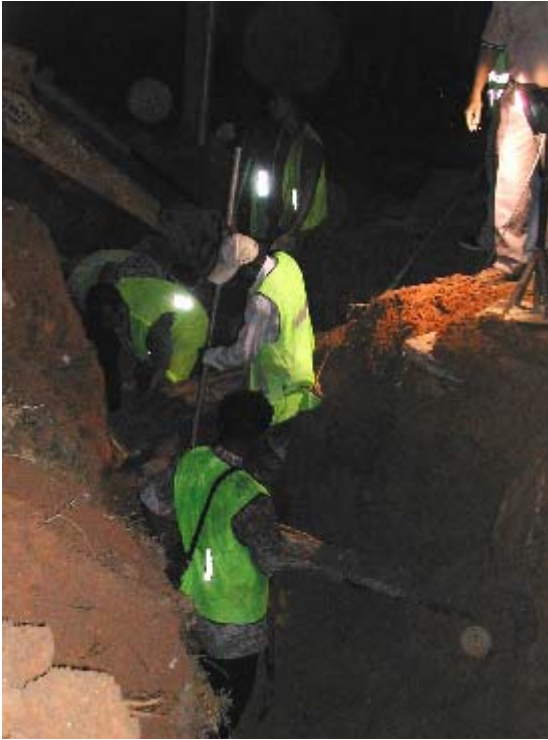
Whenever the cables or corrugated pipes crossed with any other utility cables, the usage of mechanical excavating machines, in this case a loader with backhoe attachment was stopped within one metre on either side of these cables. Instead, hoes were used to excavate the trench to the required depth. This was one reason why the trenching site required a rather large amount of general workers.

Figure 5.3: Hoes Used Whenever Cable Obstruct

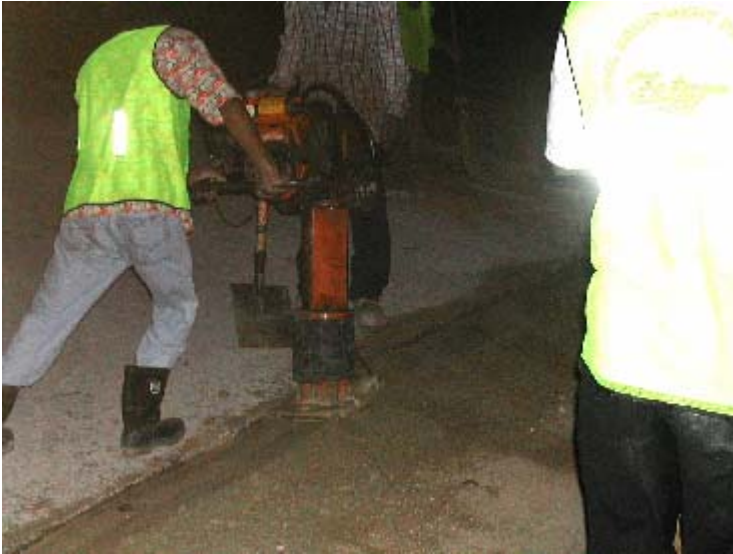
than the actual pavement, the level was expected to sink gradually with time. If the level of the pavement was found to be lower than the actual pavement after 6 months, the control authority expects the contractor to mill from the inner trench all the way to the shoulder of the road or to resurface the entire road from shoulder to shoulder.

Figure 5.4: Jumping Rammer Compacting the Soil

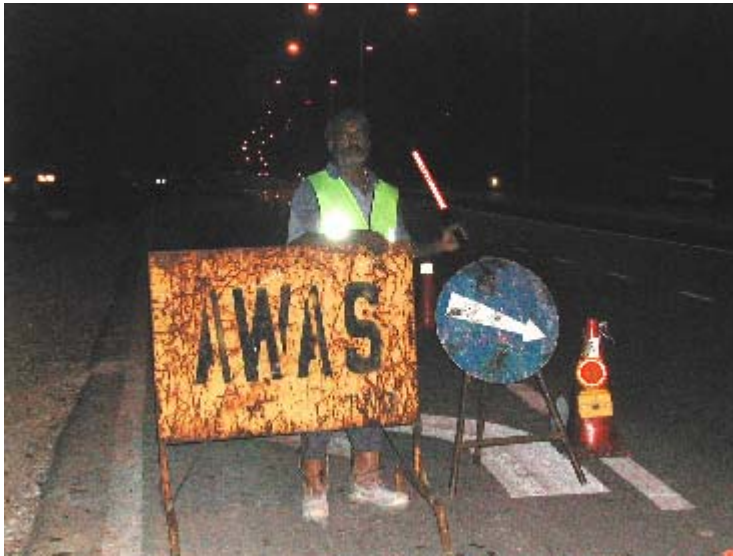
Temporary warning lights that flashed continuously were used during the whole duration of the trenching work. Temporary signboards and cone barriers were put up along the entire length of the trench to divert traffic to a safer lane. This helped ensure the safety of all road users as well as working personnel.

Figure 5.5: Temporary Warning Lights and Sign Boards

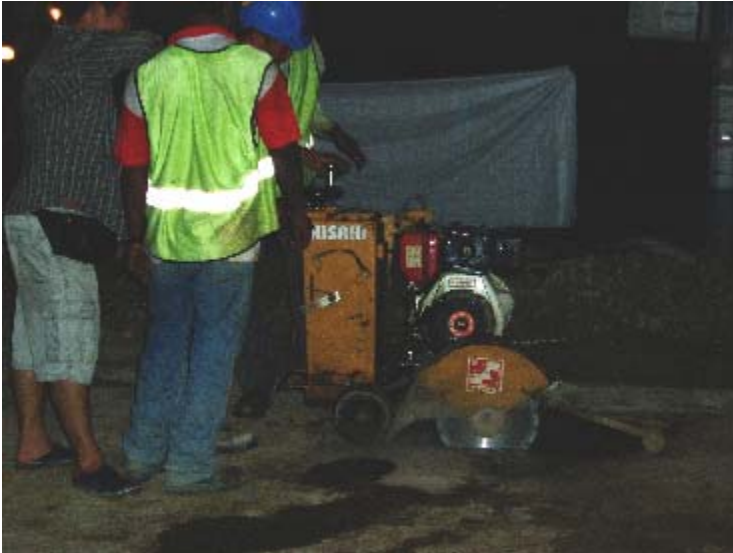
Malaysia. More than 90% of excavated work in Malaysia is done by using loaders with a backhoe attachment. Furthermore, this plant provides better stability and requires less manoeuvrability.

Figure 5.6: Diamond Cutter Cutting The Asphalt Road

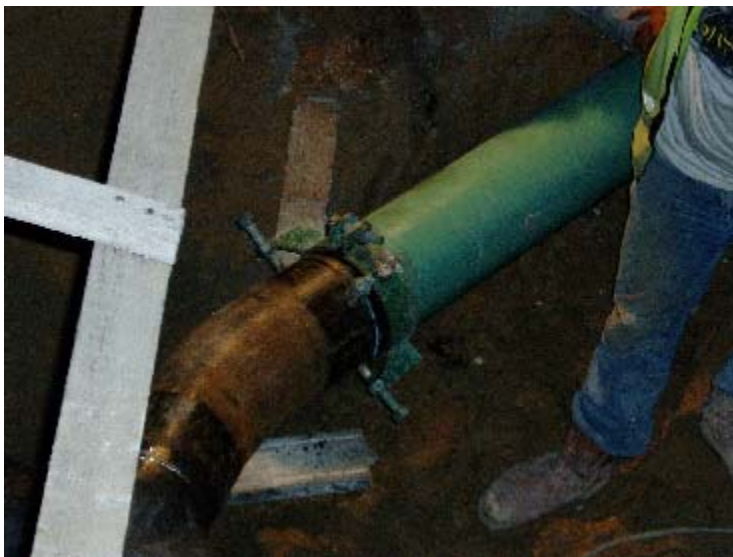
Before the piping was welded, the two pipes were clamped together using a large clamp. The piping was fully welded which meant that the entire diameter of the piping was welded together. X-ray was then done on the joint each time a pipe was welded. This ensured that the pipe was fully welded and no cracks or pinhole which would allow gas leakage to occur. After the x-ray had been done, the piping underwent cathodic protection which prevents the pipes from corrosion

Figure 5.7: Pipes Clamped Before Welding

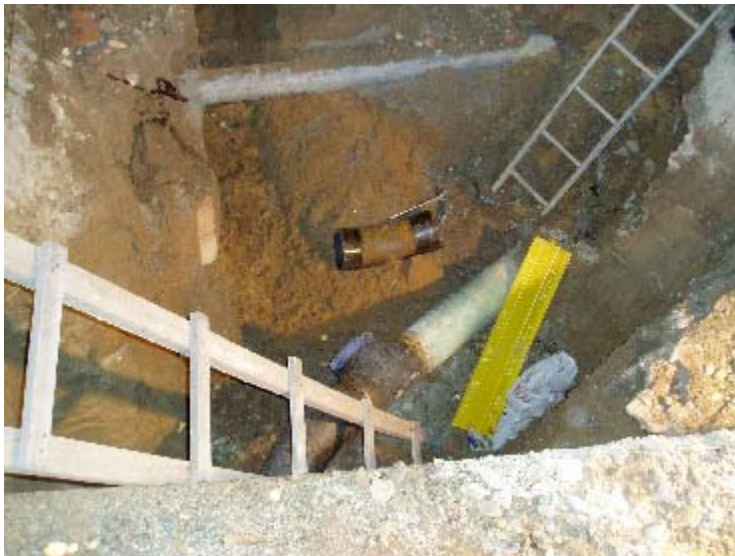
Joint pit was used whenever welding works were to be carried out inside the open trench. Usually, welding works were done inside the trench because the piping needed to be fitted with fittings of either an elbow or a tee. The size of a joint pit was almost 2 m x 2 m. The depth of the joint pit was the same as the depth of the trench, which was 1.5 to 1.75 m. The base or floor of the joint pit was also smooth and free from large rocks.

Figure 5.8: Joint Pit with Cable Obstruction

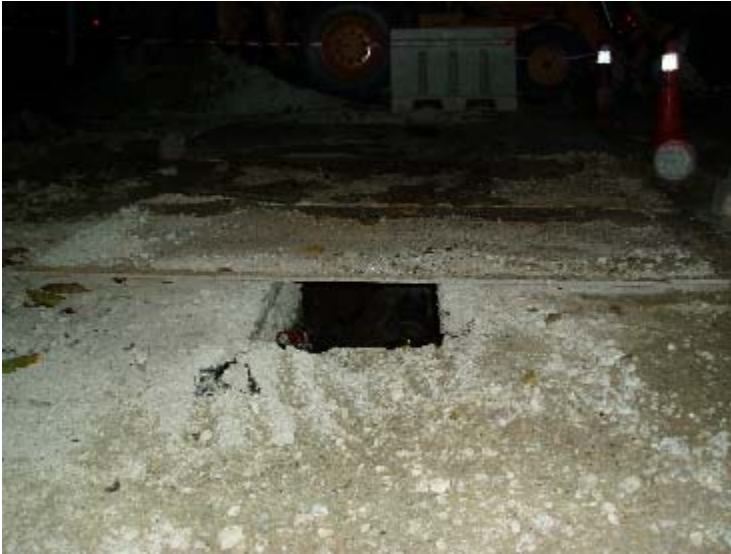
Trenches and joint pits which were left open overnight were covered using a thick mild steel plate. Mild steel plates were used because it is able to withstand and take heavy loading. This served as a safety precaution.

Figure 5.9: Covered Open Trench

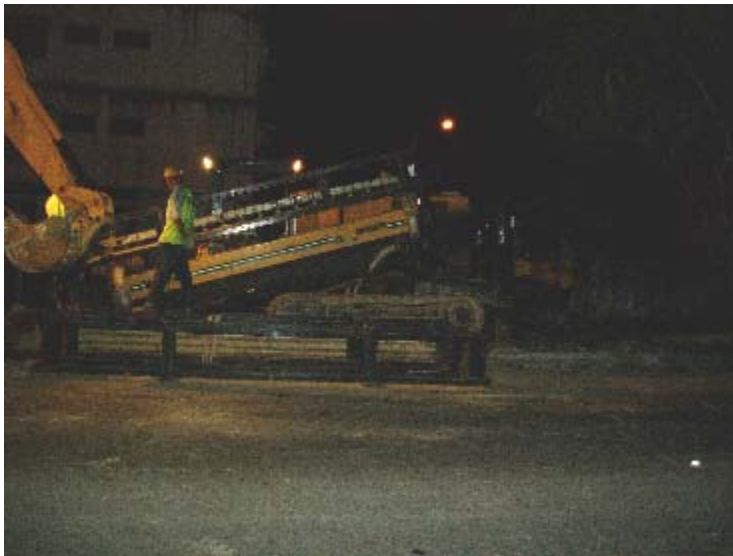
HDD was done whenever the piping was required to cross a road. Two pits were excavated, one at the front and the second at the back. However, the back pit had a maximum length of 300 m from the front pit. HDD requires a lot of water as it softens the grounds and thus makes drilling work much easier. HDD was first drilled horizontally underground across to the second pits. After drilling through, the piping was tied to a rod connected to the HDD machine. The HDD machine then pulled the rod back and thus the pipe was pulled as well. Rollers are placed at 12 m intervals to smoothen the long pipe entering and exiting the drilled hole. Both ends of the mild steel pipes were securely sealed to avoid water from entering the pipes.

Figure 5.10: Horizontal Direction Drilling (HDD)

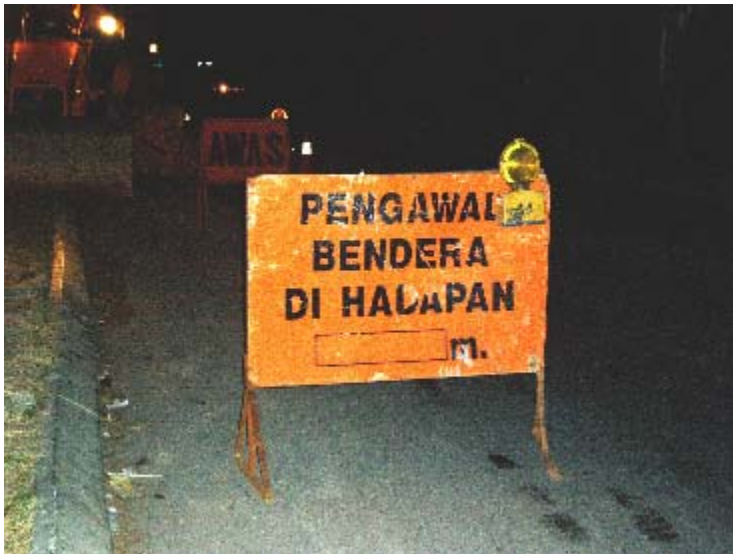
Temporary warning lights that flashed continuously were used during the whole duration of the trenching work. Temporary signboards and cone barriers were put up along the entire length of the trench to divert traffic to a safer lane. This helped ensure the safety of all road users as well as working personnel.

Figure 5.11: Temporary Sign Boards and Warning Lights

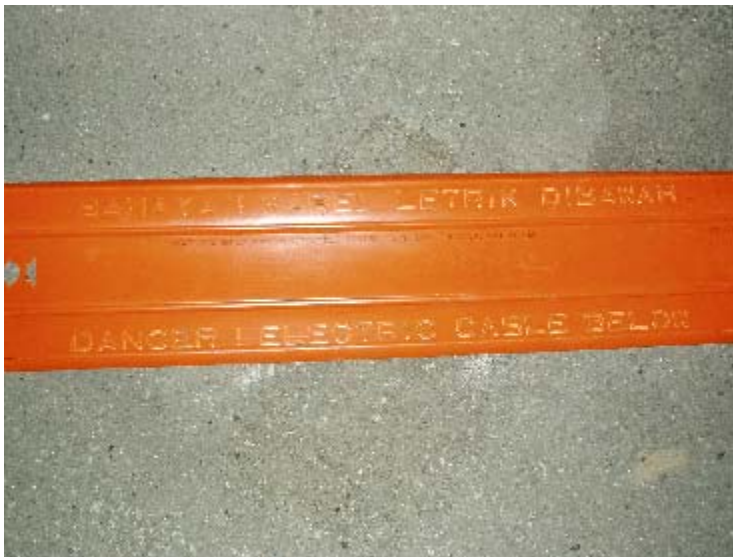
An orange protective plastic cover was used to indicate cables of 11 kV (ST cable) 300m underground while green protective plastic covers indicated 1 kV (Light Voltage [LV] cable) cables underground. 11 kV cables were used for cables linking sub-stations whereas 1 kV cables were used for cables linking sub-stations to feeder pillars.

Figure 5.12: Orange Protective Plastic Cover

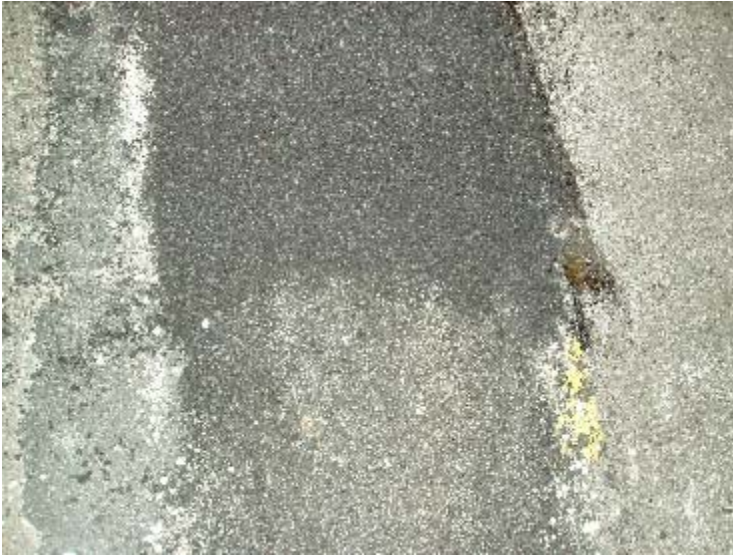
The premix was then left to cool and settle for 24 hours. The next day, a second layer of premix was applied to areas of the pavement which settled. Tack coat was applied evenly to the first layer of premix. After spreading the premix evenly, a compact roller was used to further compact the premix till it finished flush with the existing pavement. If there were signs of settlement on the premix after 15 weeks,, the entire length of the trench would have to undergo milling.

Figure 5.13: Second Layer of Asphalt, First Layer of Asphalt and Existing Road

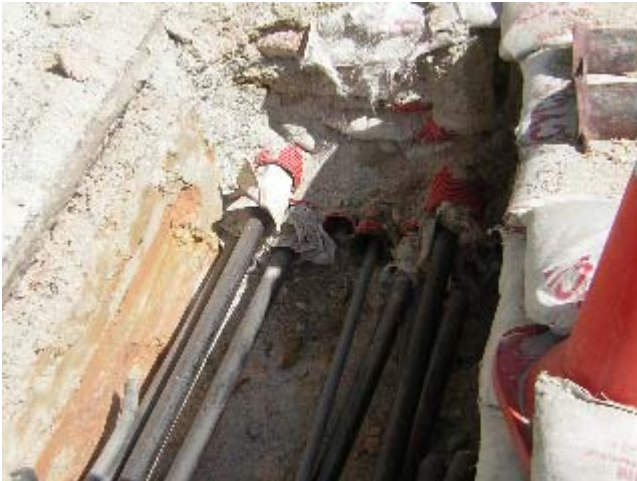
There are 3 different types of XLPE cables which are differentiated by colour – blue, yellow and red. They are placed at 120° apart. The cables are placed in such a way that the yellow cables seat on top of the blue and red. The three cables are similar to any electronic plug where yellow represents earth, red represents life and blue represents neutral.

Figure 5.14: Position of the Cables Laid

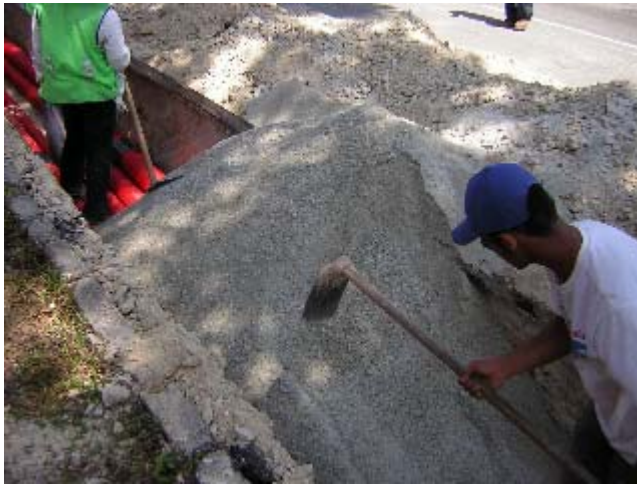
According to the project co-ordinator, quarry dust was used instead of fine sand because it costs cheaper than fine sand and works effectively.

Figure 5.16: Quarry Dust Used

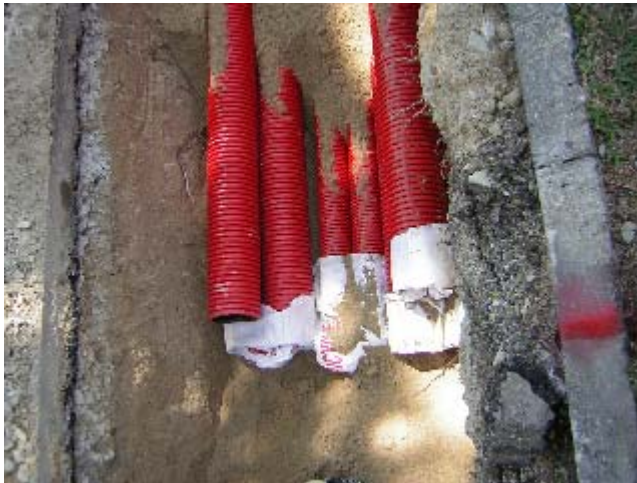
Joint bay was placed at every 50 metres. Joint bay is the place where cables are joined and tied together. The joint bays chosen had firm level ground and no obstructions. The length and width of the joint bay was 2 metres long. The end of the corrugated pipes entering or exiting the joint bay were wrapped with a gunnysack to avoid sand and water from entering the corrugated pipes.

Figure 5.17: Corrugated Pipes Wrapped with Gunnysack

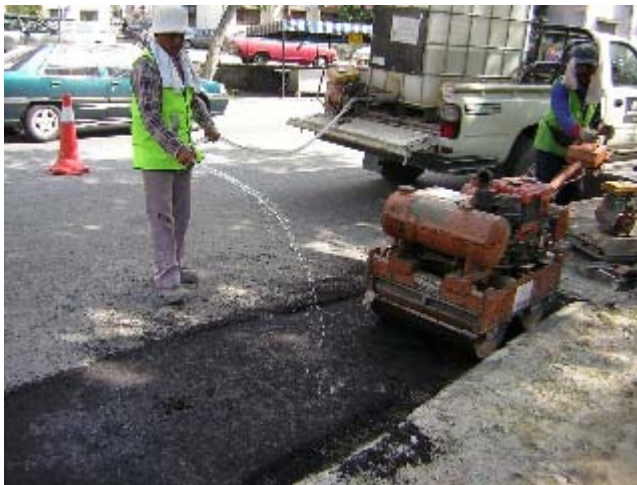
As soon as the premix arrived, it was spread onto the compacted soil. The premix needed to be very hot when premix was spread onto the compacted soil. This was to avoid premix from becoming a large chunk. However after the premix was spread evenly, water was sprayed onto the premix to cool it off. When premix cools, it enhances the bond between the premix, thus making it harder and stronger.

Figure 5.18: Water Sprayed to Cool Asphalt

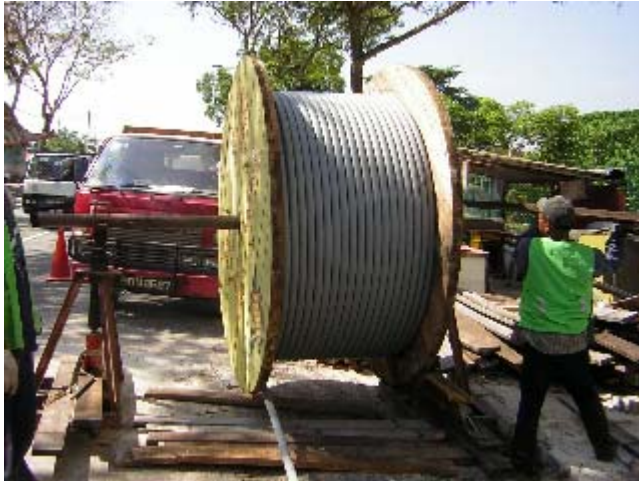
Roding was inserted into the corrugated pipe from the first joint bay all the way to the other end, which would be the second joint bay. Pulling wire rope was then tied to the roding and a WINS machine then pulled the roding along with the pulling wire rope. As the wire rope reached the first joint bay, power cables or pilot cables were then tied to the wire rope. The wire rope and the cables were then pulled by another WINS machine to the second joint bay. The above method was repeated until the cables reached the desired locations.

Figure 5.19: Installation of Cable

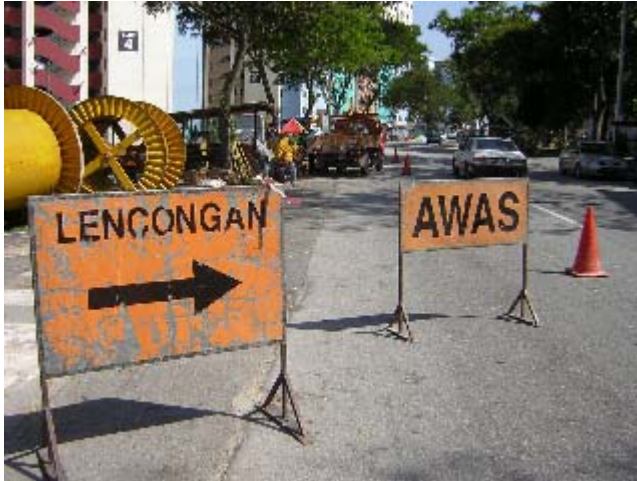
A temporary signed board was placed at 100 metres away from the working site to warn road users of the work carried out in front. The signboards were maintained until the installation of cables had been completed and disturbed surfaces were reinstated

Figure 5.20: Temporary Sign Boards

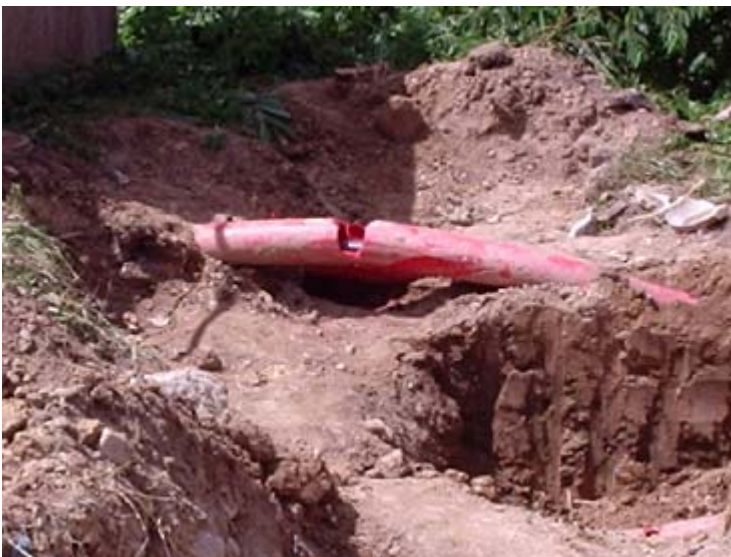
Whenever the cables or corrugated pipes crossed with any other utility cables, the usage of loader was stopped within 1 metre on either side of these cables. Instead general workers used hoes to excavate the trench to the required depth. The trenching work was slowed tremendously whenever cable obstruction occurred.

Figure 5.22: Obstructing Cable Damaged During Excavation

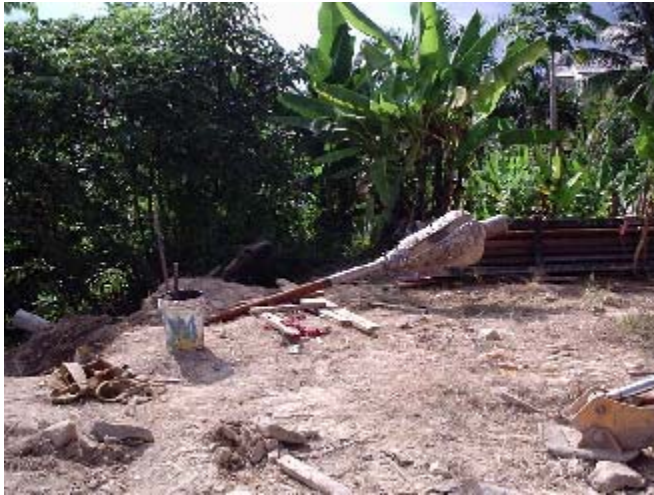
The first length of the drill rod guided by the drill head was rotated and jacked into the ground without any bending. When the end of the first drill rod reached the jaw of the machine, the first rod was considered drilled into the ground and the second rod was then joined at its end. Bending started during the second rod drilling.

Figure 5.24: Drill Head of the HDD

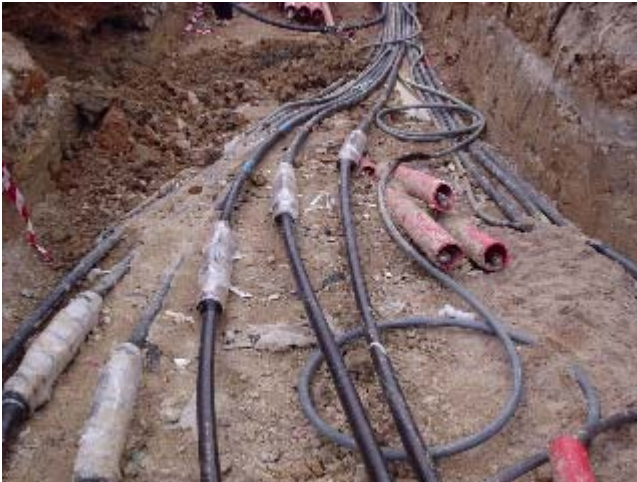
The above procedures were repeated until all cables were pulled from JB1 to JB3. After all cables were laid, testing of cables was conducted as required and witnessed by TNB.

Figure 5.25: Cable Joining
